# DETERIORATION AND REPAIR OF ABOVE GROUND CONCRETE WATER TANKS IN ONTARIO, CANADA

REPORT TO  
ONTARIO MINISTRY OF THE ENVIRONMENT

September, 1987

Golder Associates

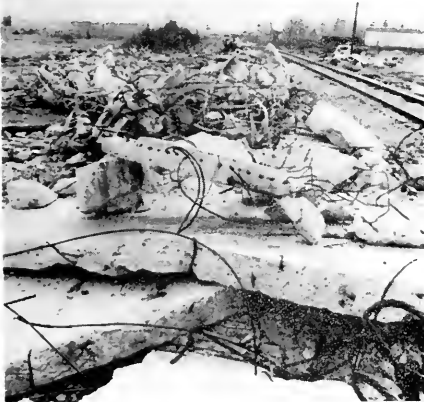
Photo 1-1 Collapsed tank (DUNNVILLE)

The study revealed (Ref. 1 and 2) that a large number of the water tanks inspected had deteriorated significantly over a short period of time. Although it was expected that the life of a water tank should be in excess of 50 years, most of the tanks studied were less than 9 years old, with an average age of about 6 years. It was noted that two water tanks had structurally failed.

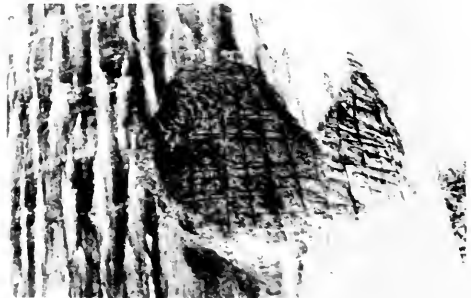
*Photo 2-2 External wall delamination (WATFORD)*

Similar delamination was found during repair of the ALVINSTON tank where large areas of external and internal delamination generally occurred on the side of southern exposure. One interesting observation from this tank was that an internal epoxy resin coating had been applied to the lower 6m (20 ft.) of the tank and all major delamination had occurred above this level.

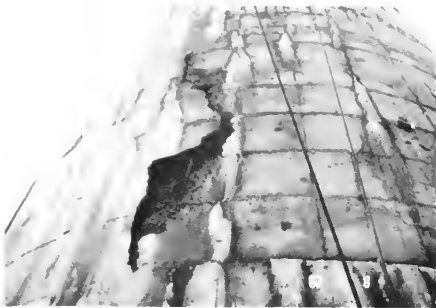
**Photo 2-3** *External wall delamination (CAMLACHIE)*

A third reinforced concrete standpipe also exhibited extensive wall delamination (CAMLACHIE) and was eventually replaced by a new tank. Photos 2-3 and 2-4 show the major spalled areas. As with the other reinforced concrete tanks, no corrosion of the reinforcing steel was observed.

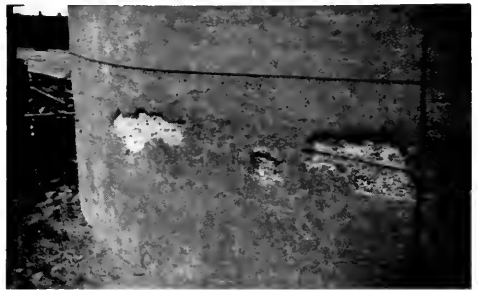
**Photo 2-8** External delamination in wire wound post-tensioned tank (WOODVILLE)

surface, external delamination was likely; furthermore, reinforced concrete standpipes particularly in the southern lower portions of the tank, appeared to be more susceptible to external delamination than other tank types including elevated prestressed concrete tanks. In comparing standpipes, it appeared that post-tensioning reduced the likelihood of external delamination except where internal spalling had reduced the wall thickness. It was concluded that the physical factors involved were the availability of water, pressure, and southern exposure, with radial compression being a mitigating factor.

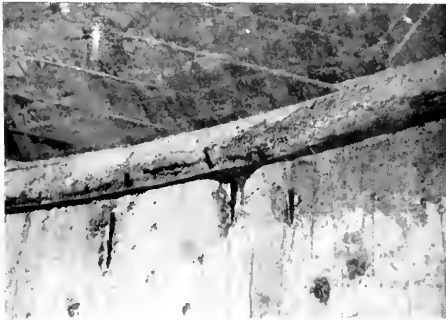
**Photo 2-10** *Localized spalling (BADEN)*

Localized spalling had occurred at many tanks and could not be associated with any tank type in particular, however, it was noted that in the majority of cases the localized spalling was associated with a shallow depth of cover to the reinforcing steel or with individual aggregate particles (Photo 2-10).

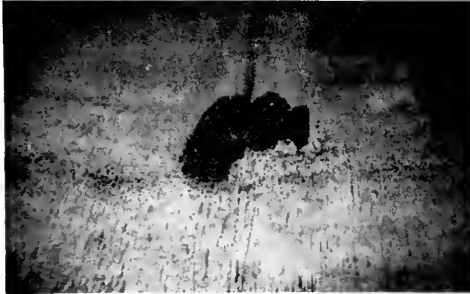
**Photo 2-13** *Coating deterioration and a jack-rod spall (WOODVILLE)*

In the majority of tanks, the internal coating had deteriorated away from the wall (Photo 2-13). Examination of core sections revealed that in most cases the surface of the concrete was fractured to a depth of between 5 mm and 15 mm. In some cases the deterioration was so extensive that the remnants of the coating could only be detected by microscopic examination.

Deterioration of this nature did not appear to be associated with tank type but seemed to be a function of coating type and quality (see report to Ministry of the Environment (1985) titled "Evaluation of Waterproof Coatings for Concrete Water Tanks" where this subject is discussed more fully).

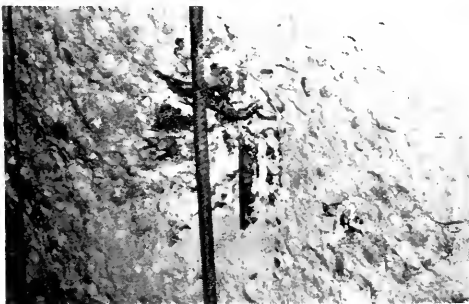
**Photo 2-14** *Jack-rod spall at threaded coupling (BADEN)*

Some tanks had been constructed using a slip form method. Hollow pipe rods, known as jack-rods, each approximately 3 m in length are used to raise the slip form. As construction proceeds, additional lengths are added using threaded coupling rods. This results in hollow tubes at approximately 3 m centres extending the full height of the tanks and interrupted at each joint by the solid rods.

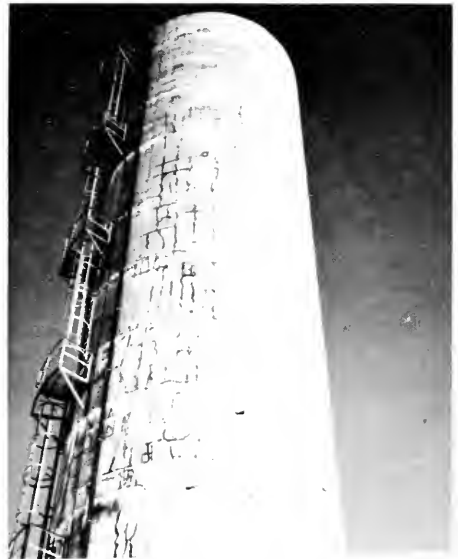
Photo 2-18 Deterioration of reinforced concrete standpipe (ALVINSTON)

day. As stated above, some concrete tanks were constructed using air entrained concrete. Other tanks due to the concrete application method, were not air entrained. Although in most cases the air entrained concrete contained less air than desirable, nevertheless, most of the examples given are within the limits of "acceptable quality" as judged by the Ministry of Transportation and Communications Bridge Deck Rehabilitation manual (Ref. 3). Thus, it can be stated that the presence and pattern of deterioration was not consistent with the lack, or otherwise, of air entrainment. Furthermore, it was considered that, since most of the concrete standpipes exhibited external deterioration at the bottom of the tanks it would be a remarkable coincidence if all poor quality concrete was placed in the lower sections of these tanks and all durable concrete was placed in the uppermost sections.

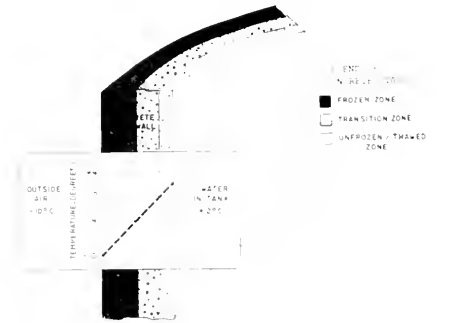
a) Ice free condition (autumn - winter)

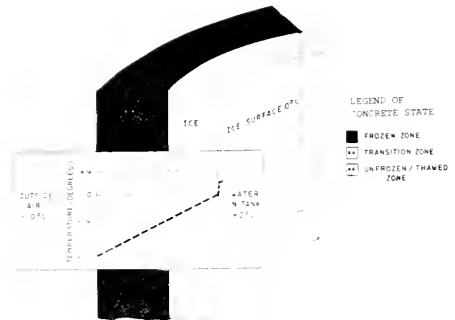
early spring. In this case, a significant thickness of ice has formed on the inside surface of the concrete. The presence of this ice prevents any buffering effect from the internal water

b) Ice ring present inside the tank

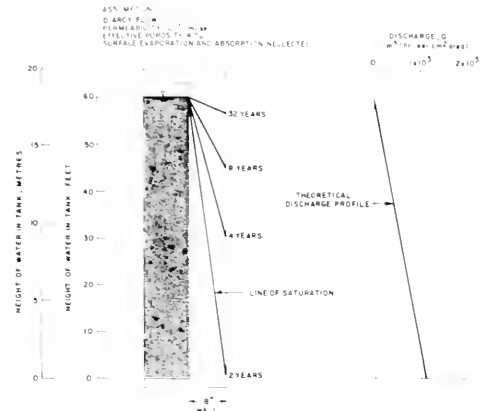
It is only after the concrete becomes saturated to a critical level, above 90%, that the action of freezing and thawing, which was previously harmless, starts its destructive action. It can be demonstrated that even the highest quality of concrete will achieve this state under the pressure conditions prevailing in a typical concrete standpipe.

Figure 4.1 Theoretical saturation zone and seepage discharge

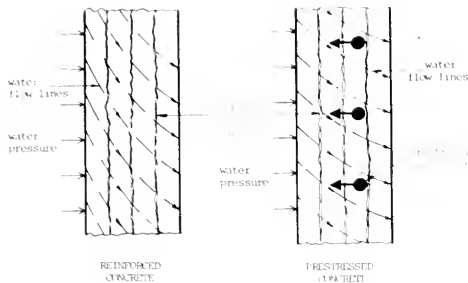
In addition to the factors previously described, placement conditions and the presence of stress affect the permeability (see Figure 4.2). Mills (Ref. 16) found that the permeability of concrete was greater in a direction parallel to bleeding and that the

**Figure 4.2** Relationship between bleed water paths, water pressure flow and stressing force in water tank walls.

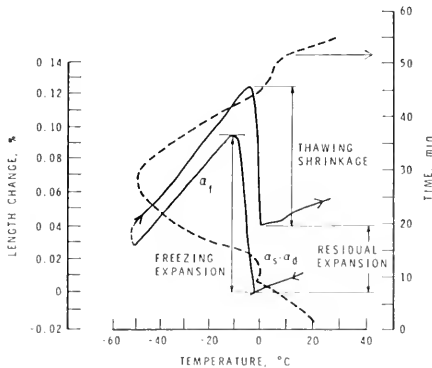
Also plotted on the right hand axis of Figure 4.4 is the time history during freezing and thawing. The dashed line (time v's temperature) shows that the entire cycle is completed within 1 hour and that both during the freezing cycle, and also, during the thawing cycle, a delay occurs at -4°C and 0°C respectively, indicating that heat is

**Figure 4.4** Typical experimental length change results from thermomechanical measurement (ref. 18)

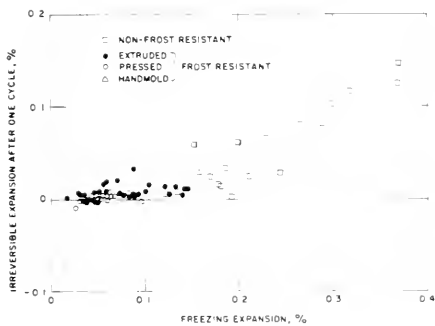
Figure 4.7 Relationship between irreversible expansion and freezing expansion of frost resistant and non-frost resistant bricks (ref. 18)

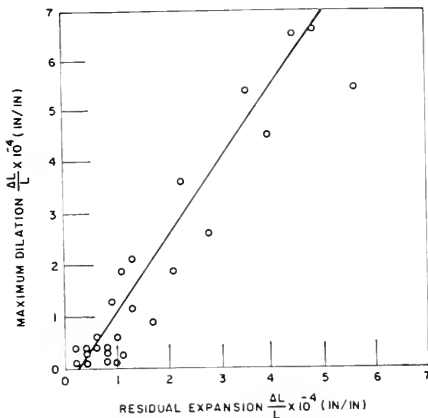
This research by MacInnis corroborates other researchers who report that there is a critical degree of saturation required for dilation to occur. Additionally, it suggests that under the saturation procedure used the entrained air voids may be filled, rendering them ineffective against frost action. It is argued that this is also likely to occur under hydrostatic pressure; this would be consistent with the deterioration of concrete water tanks in their lower section regardless of the presence or magnitude of entrained air.

Figure 4.8 Maximum dilations v's residual expansions after one freeze - thaw cycle for "fully" saturated specimens (ref. 22)

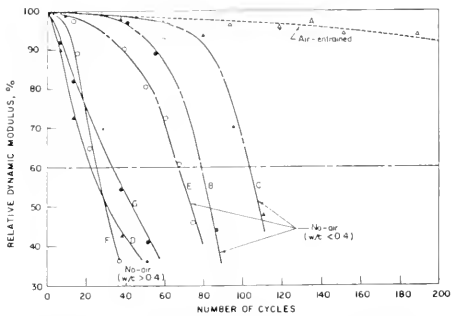
a) Relative dynamic modulus (ASTM C666)

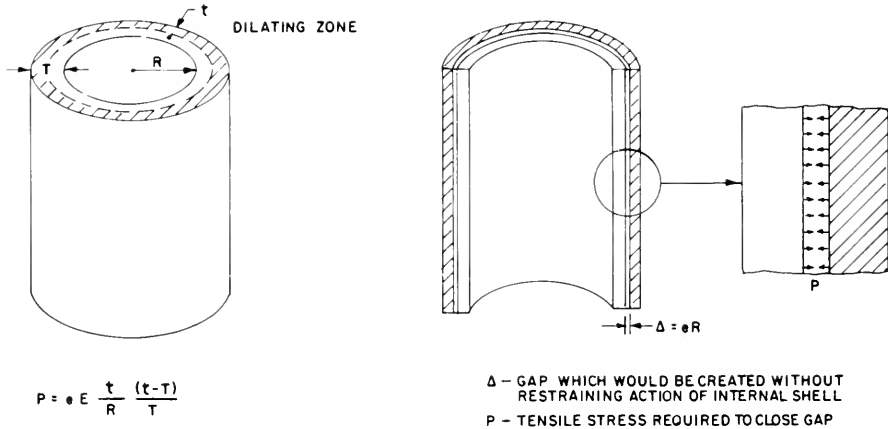
In practice however, a concrete member can be fully saturated and only frozen to a limited depth. In this circumstance, part of the concrete member is dilating while the remainder is unaffected by frost. Under this condition, the dilating concrete is restrained and will produce reaction forces, the magnitude being dependent on the geometry of its constraints and on the magnitude of unconstrained dilation.

**Figure 4.13** *Theoretical model of tank stress development*

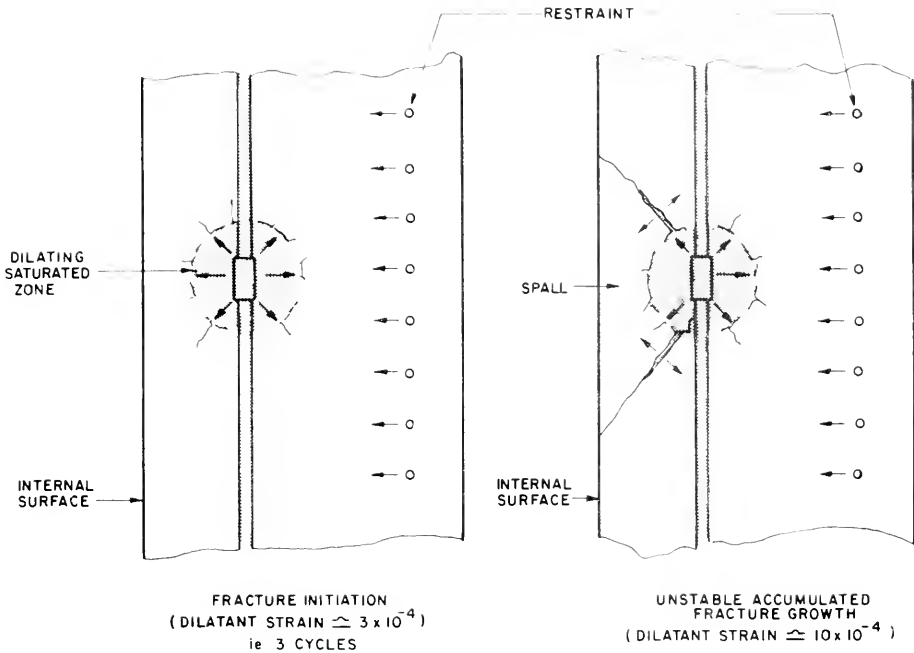
Figure 4.22 Formation of jack-rod spalls

which would dilate on freezing. The concrete outside the zone would provide a restraint to dilation and tensile stresses outside of the dilating zone would be developed. (see Figure 4.22).

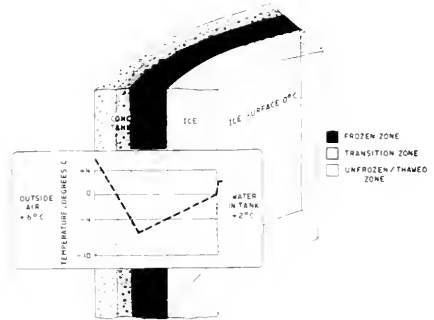
a) Thermal profile produced by frozen internal wall section

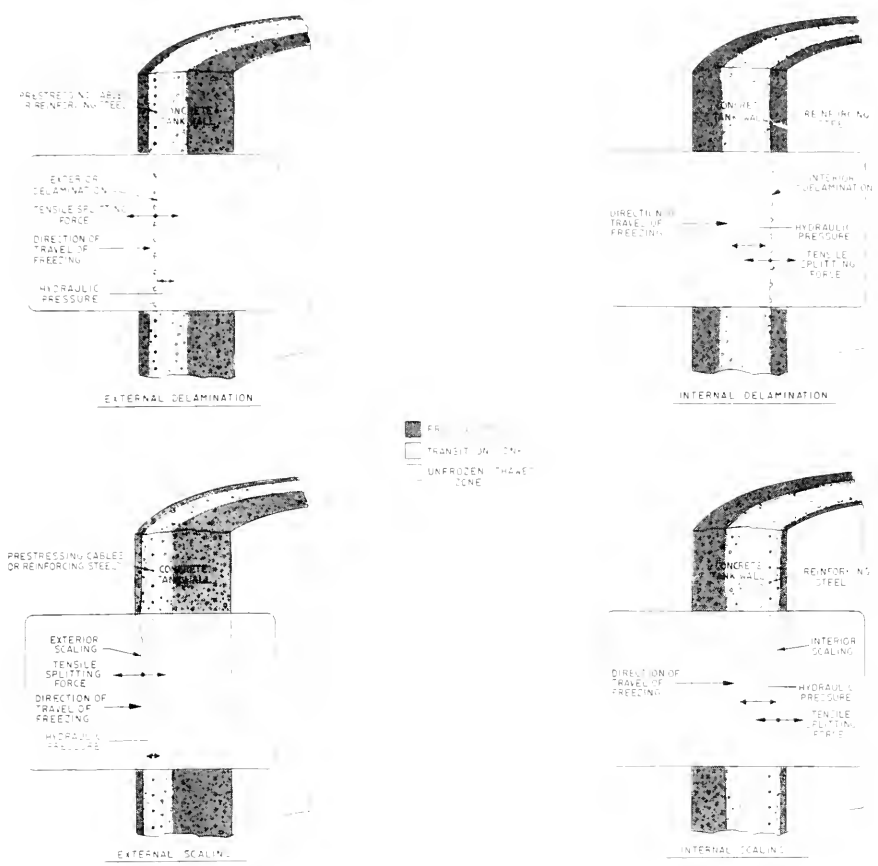
Calculations show that a dilating zone of about 25 mm radius (1 in.) will initiate local fracture when the dilating strain is

Figure 4.24 Nature of wall damage at location of unfrozen zone

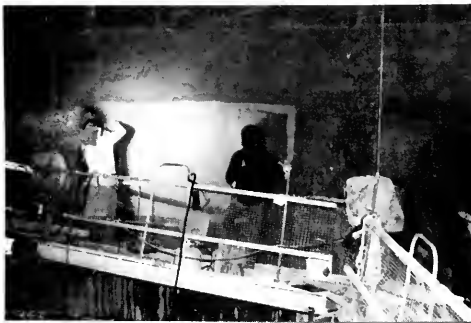
**Photo 5-2** Surfacing tank wall prior to application of coating. (HESPELER)

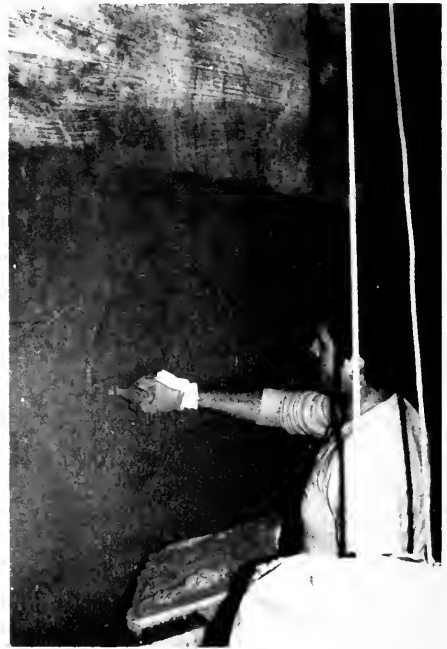
**Photo 5-3** Trowelling latex modified mortar. (HESPELER)

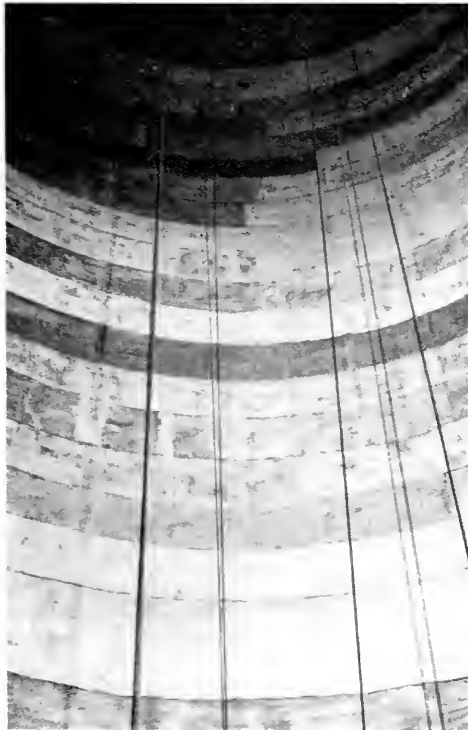
**Photo 5-4** Completed surfacing prior to coating application. (HESPELER)

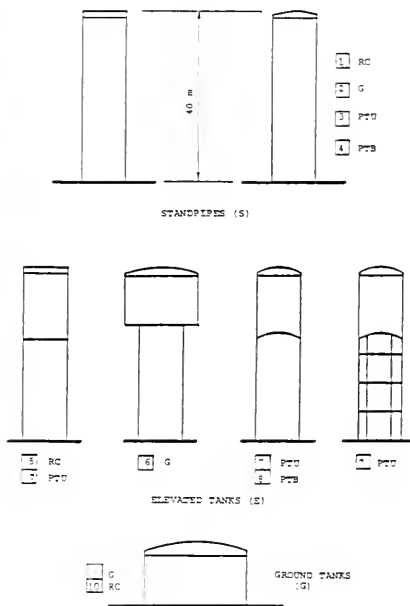
**Figure 5.1** The 10 Concrete tank types in Ontario (see Table 1/1 page 1-3 for description and abbreviations)

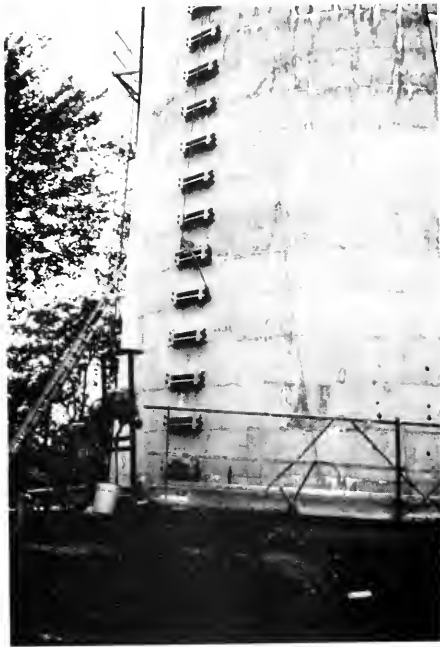
*Photo 5-5 Installation of post-tensioning anchors. Note leaks at construction joints. (ALVINSTON)*

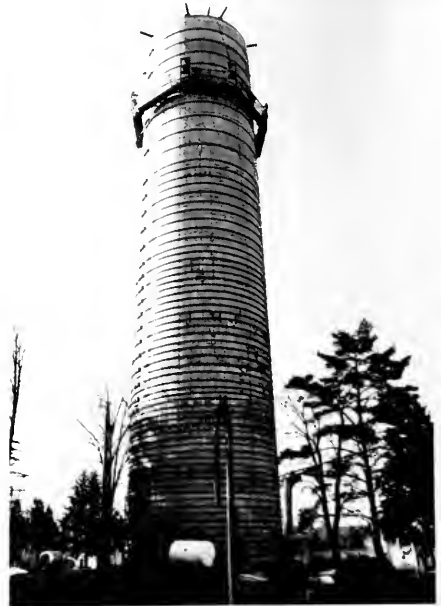
*Photo 5-6 Installation of external post-tensioning tendons. (ALVINSTON)*

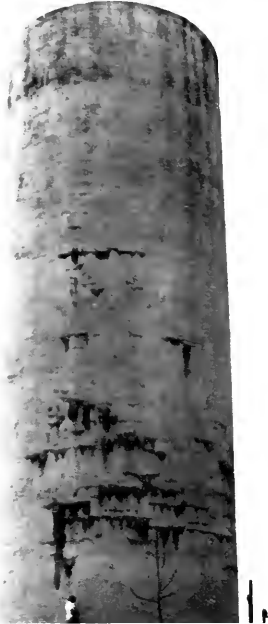
**Photo 5-7** Typical horizontal cracking of a G-S type tank. (L'ORIGINAL)

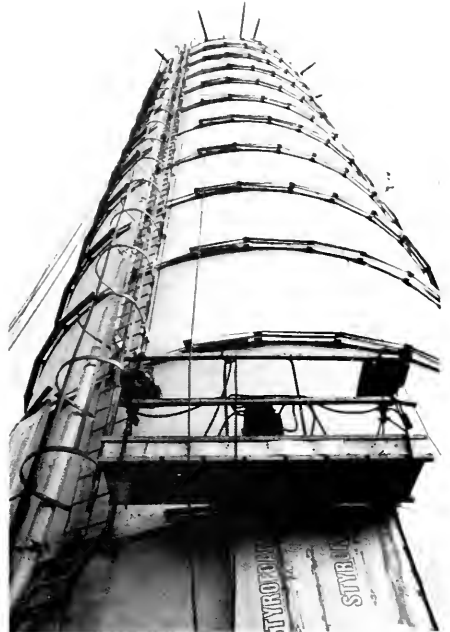
**Photo 5-8** Ring support structure for insulation and cladding. (BADEN)

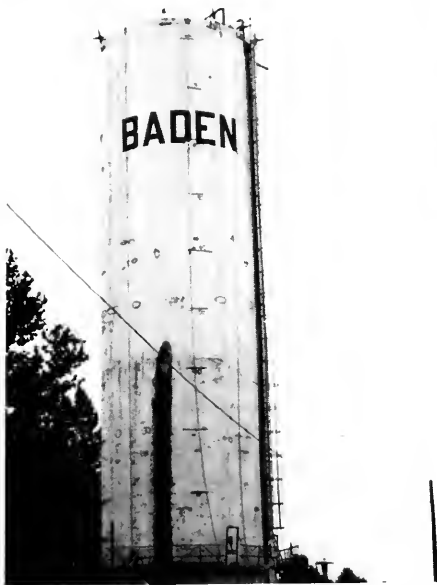
**Photo 5-9** *Standpipe prior to repair (BADEN)*

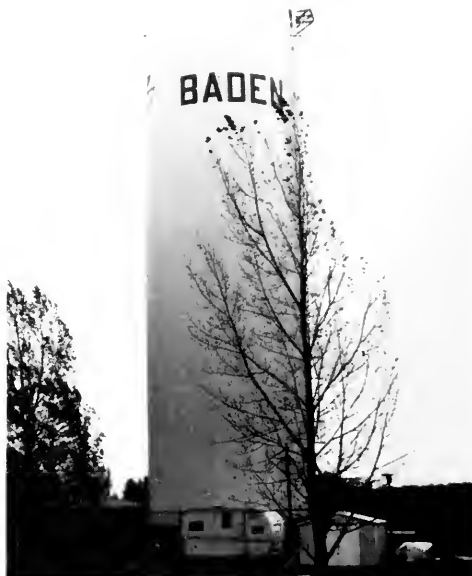
**Photo 5-10** *Standpipe after insulation (BADEN)*

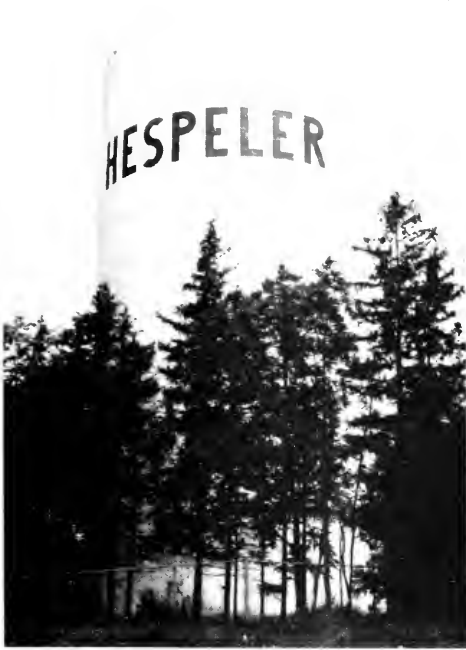
**Photo 5-12** *Standpipe prior to repair (HESPELER)*

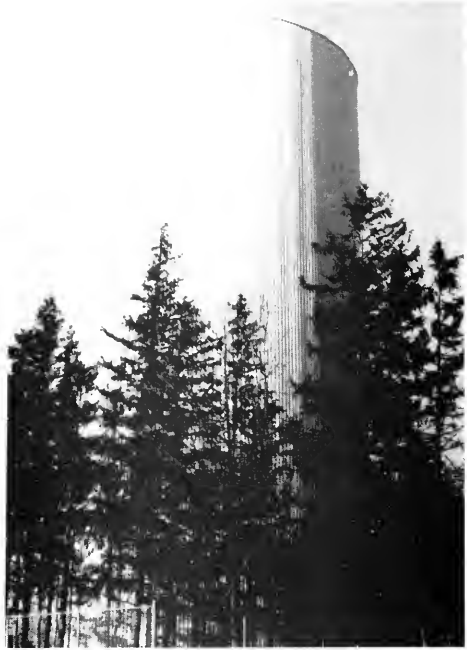
**Photo 5-13** *Standpipe after insulation (HESPELER)*

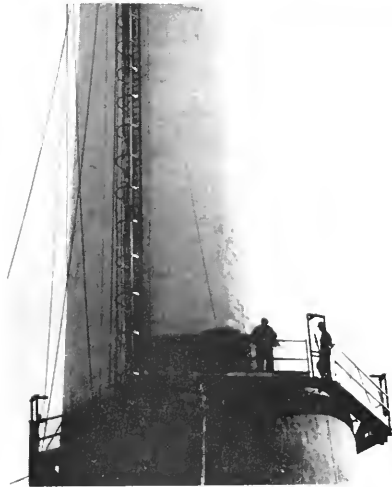
**Photo 5-14** *Applying coat of MMA to exterior of standpipe (BADEN)*

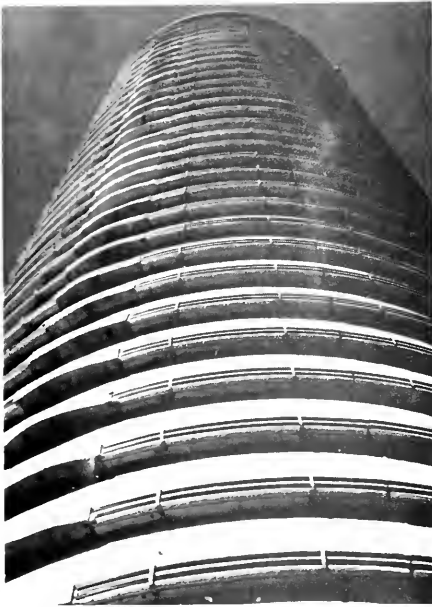
Photo 5-15 External post tensioning (GLENCOE)

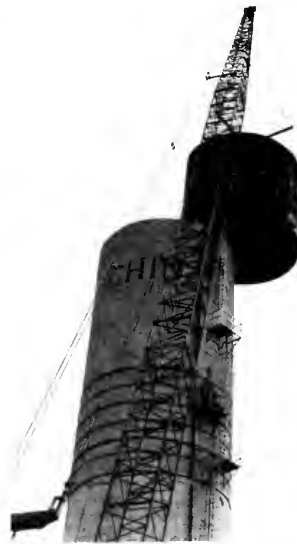
Photo 5-16 Steel liner being installed. Note external post-tensioning (BRECHIN)

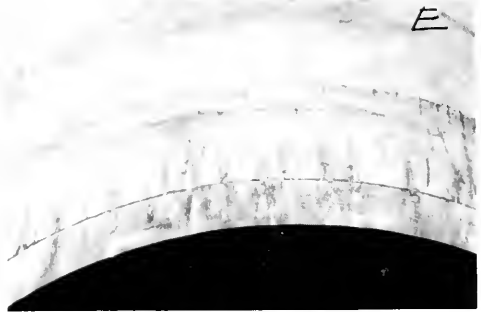
**Photo 5-19** Vertical cracking at base of wall due to ineffective prestressing. This was caused by inadequate provision for inward movement between internal thrust ring and wall. (CHELMSFORD)

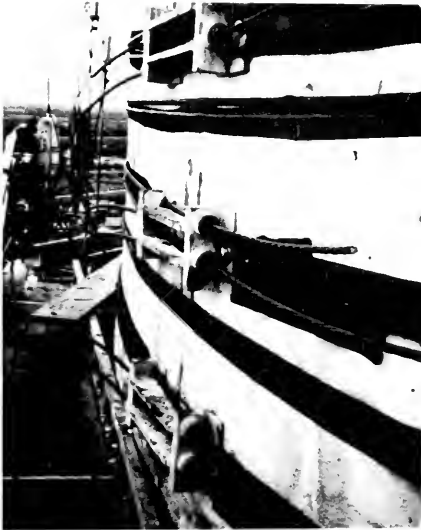
**Photo 5-20** *External post-tensioning added to compensate for lack of prestressing in wall. (AMHERSTBURG)*

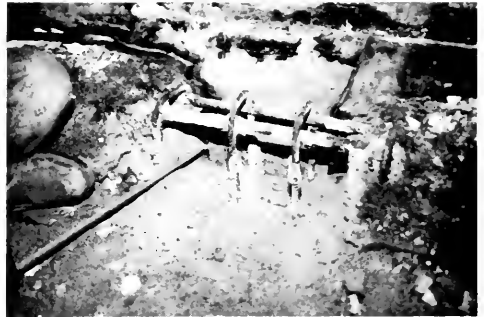
**Photo 5-21** *Deteriorated internal thrust ring. Note thrust block against wall stopping movement. (CHELMSFORD)*

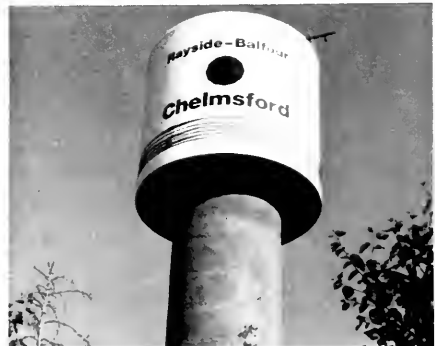
**Photo 5-23** *Completed repair. Note external tensioning at base of tank. (CHELMSFORD)*

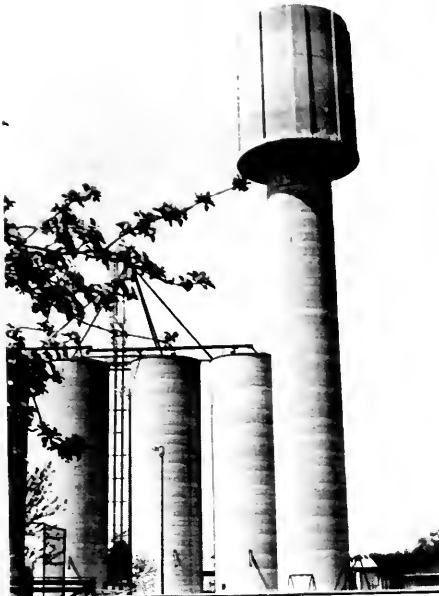
**Photo 5-24** Tank after leakproofing and before insulation.(BRIGDEN)

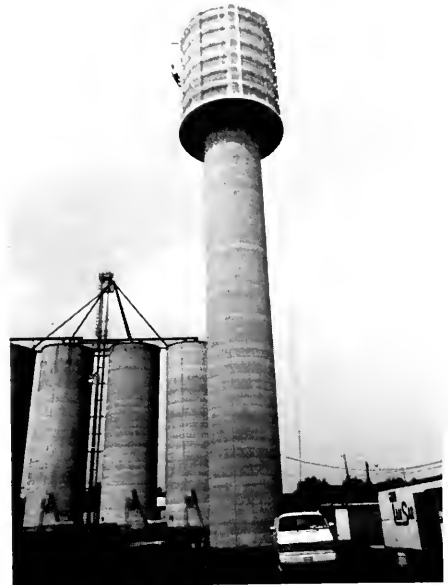
**Photo 5-25** Steel support system for insulation and cladding. (BRIGDEN)

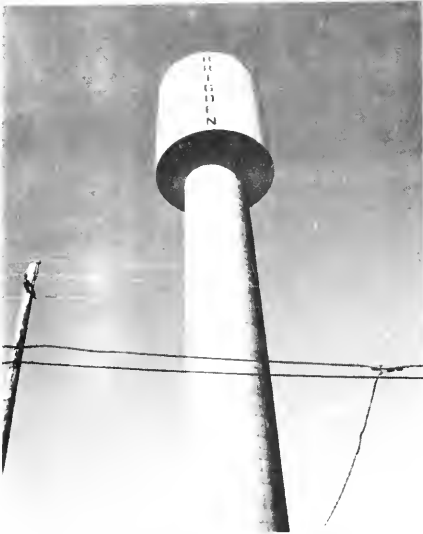
**Photo 5-26** Completed rehabilitation of tank. (BRIGDEN)

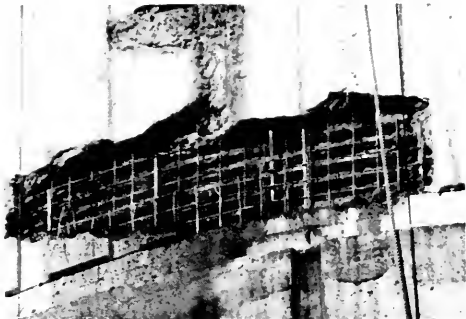
**Photo 5-28** *Delaminated wall. Inspection revealed ungrouted post-tensioning ducts at this region. (CASSELMAN)*

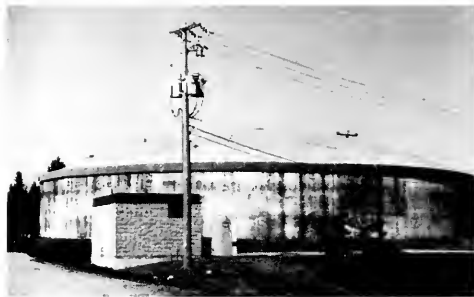
**Photo 5-29** *Reservoir before repair (PRESTON)*

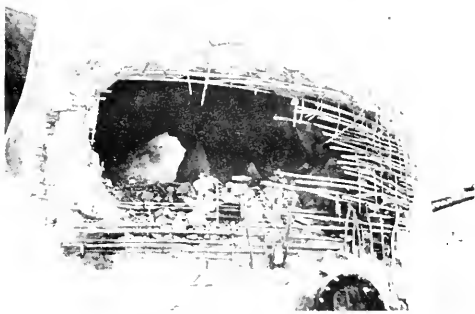
**Photo 5-31** Tank demolition - cutting hole at base. Note ice still inside empty standpipe. (CALLANDER)

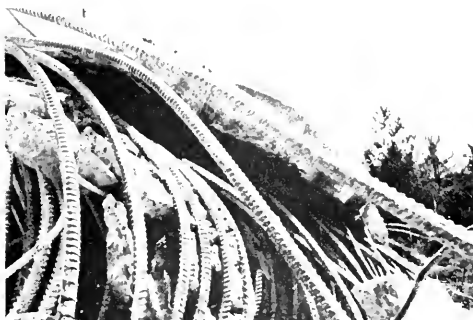
**Photo 5-33** Reinforced concrete tank wall after toppling. Note no corrosion of steel and delamination of concrete from steel. (CALLANDER)

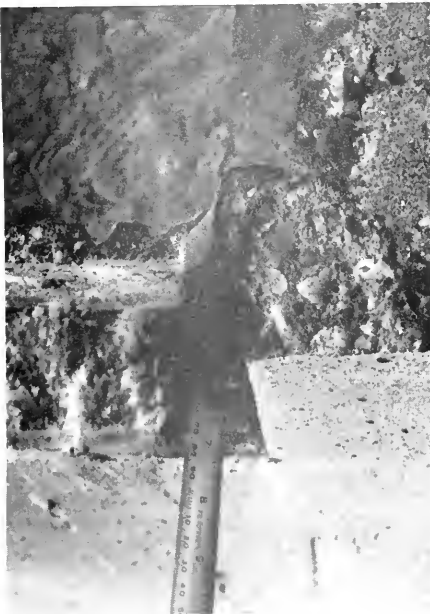
Photo 6-1 Poorly protected post-tensioning anchorage allowing water to enter. (BRIGDEN)

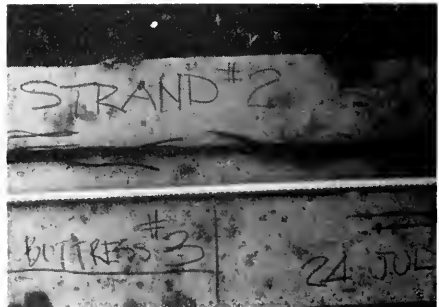
Photo 6-2 Detailed view of strand showing corroded wires. (BRIGDEN)

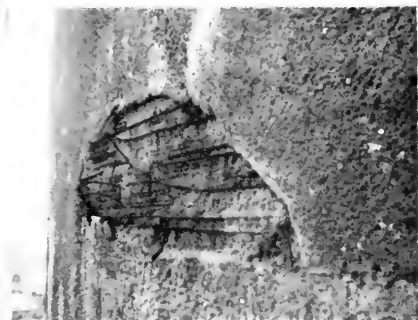
**Photo 6-5** *Delaminated cover coat exposing broken prestressing wires (AMHERSTBURG)*

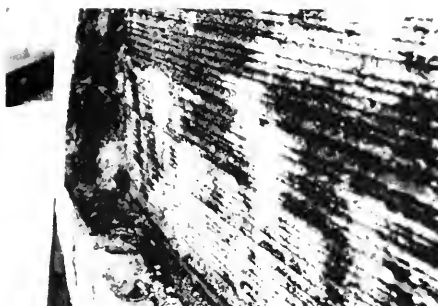
**Photo 6-6** *Corroded prestressing wires under delaminated cover coat (CHELMSFORD)*

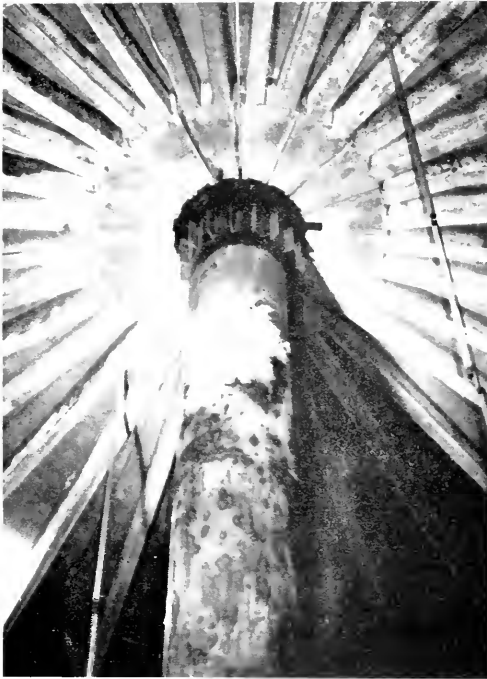
*Photo 6-7 Corroded access tube  
(PRESCOTT)*

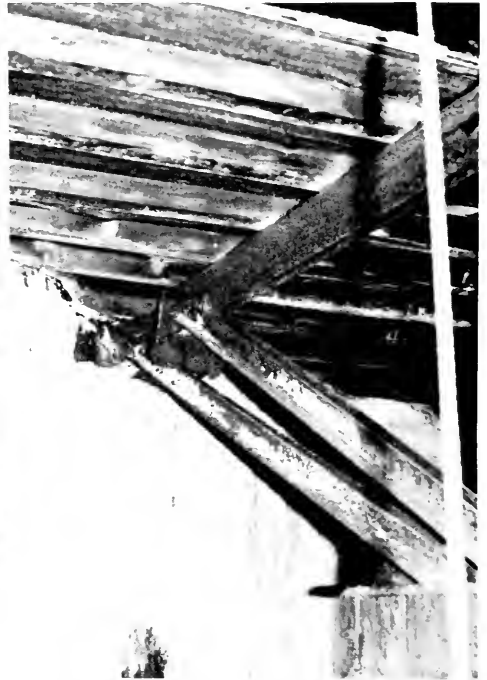
*Photo 6-8 Corroded roof truss  
(HESPELER)*

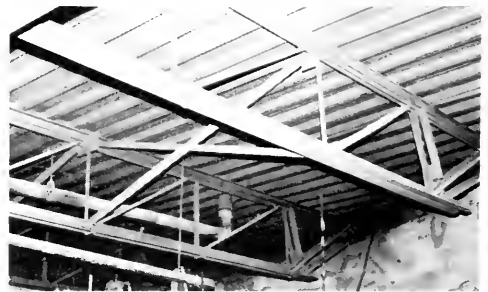
*Photo 6-9 Completed roof repair  
(HESPELER)*

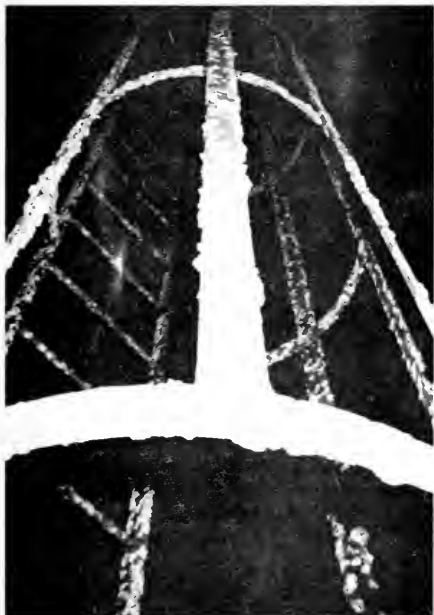
Photo 6-10 Aluminium ladder exhibiting severe pitting corrosion (BRIGDEN)

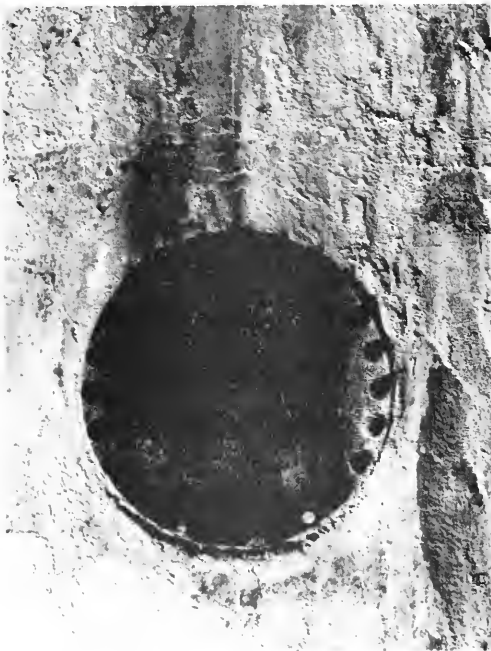
Photo 6-11 Corroded steel manway cover and bolts. (WATFORD)

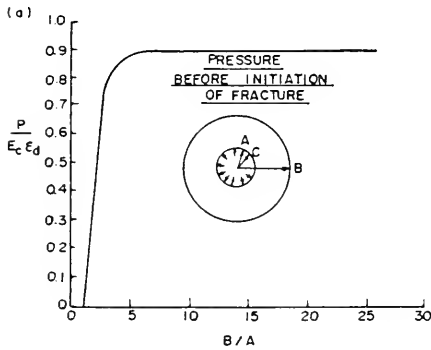
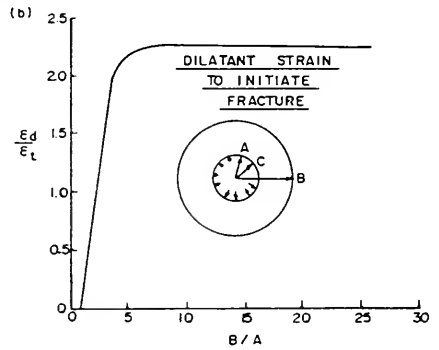
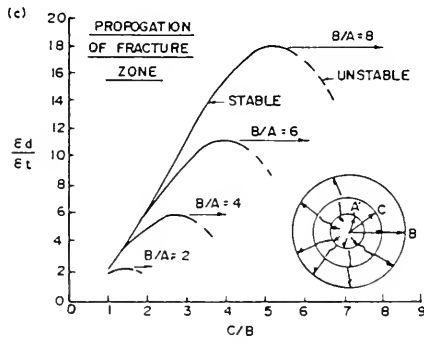
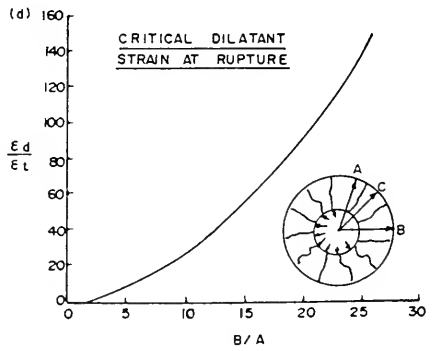
Figure 12.1 Rupture of a brittle sphere due to dilation
